TNO-report 98-CMC-R0328

IMPACT ON A STEEL SONAR DOME

TNO Building and Construction Research

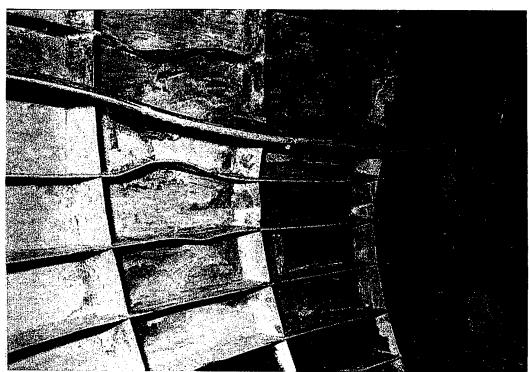
- 1. On the inside of the dome two large stiffeners are visible in the damaged area: a longitudinal stiffener and a transversal stiffener, see Figure 6.
- 2. The direction of impact is of influence.
- 3. The object which hit the dome had sharp edges.
- 4. A combination of the three hypotheses given above.

On the inside of the dome (Figure 6) we see tilting of the top horizontal primary stiffener over three vertical secondary stiffener distances. Also local buckling of secondary stiffeners is visible.

Figure 6 Inside view of damage: tilting of horizontal primary stiffener and local buckling of horizontal secondary stiffeners

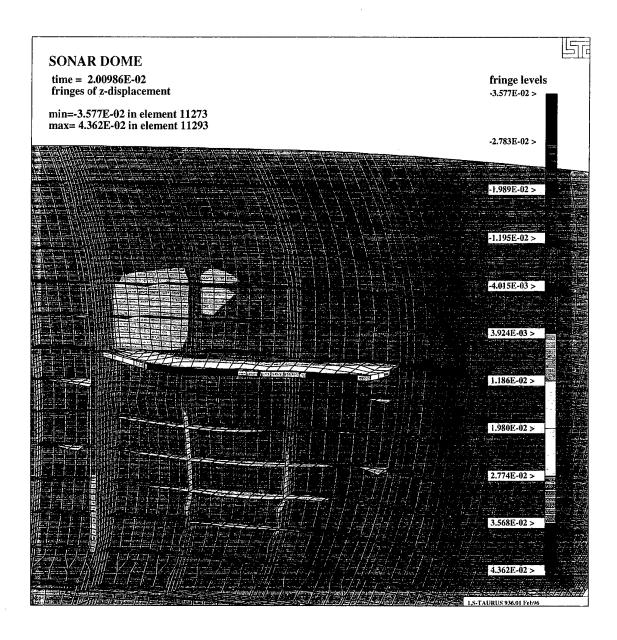
Figure 17-Figure 20 show the contour plots of the displacement in x, y and z-direction and the total displacement for t = 0.02 s respectively. The damaged area is approximately circular with a radius of 0.4 m, which is the same radius as calculated from Figure 4. Therefore the situation at t = 0.02 s will be investigated in detail. The centre of the damaged area has a maximum displacement of 0.2 m.

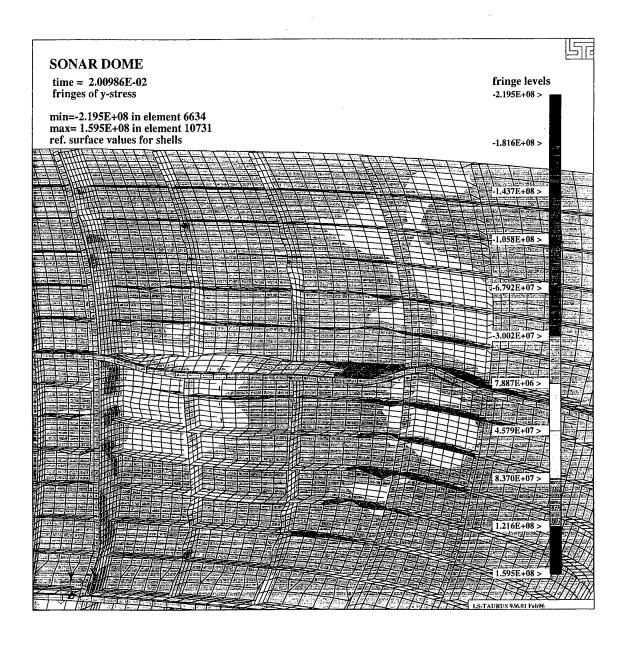
Figure 23-Figure 25 show the stresses in x, y and z-direction respectively for t = 0.02 s. In the region where there is direct contact between the sphere and the dome we see tensile stresses up to 314 MPa. Just outside the region of contact we see compressive stresses up to -242 MPa.
